WESTPORT PUBLIC SCHOOLS COLEYTOWN MIDDLE SCHOOL

BUILDING ENVELOPE & HVAC SYSTEMS EVALUATION and RECOMMENDATIONS

December 12, 2018

KG+D Architects, P.C.
OLA Consulting Engineers
Watsky Associates

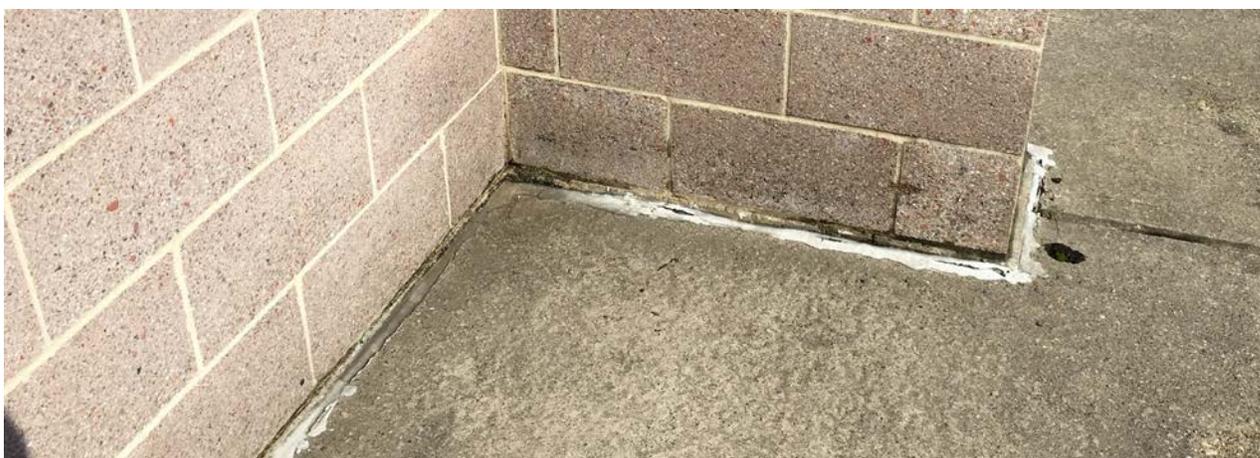
There are many locations where concrete sidewalks are directly adjacent to the building and are at the same elevation as the interior floor to which they abut. Significantly, many of these hard surface conditions are level and do not slope away from the building. The consulting team even observed some locations where the concrete surfaces sloped toward the building. The conditions contribute to water infiltration into the building.

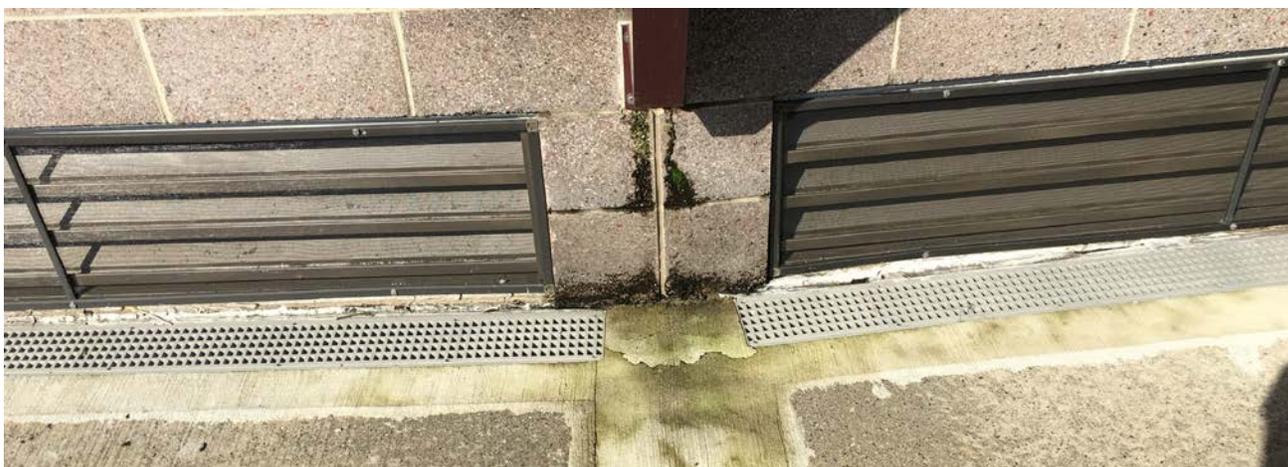
Sidewalks aligning with interior floor levels are an even greater problem where the bottom of the louver penetrations for the unit ventilators (UVs) are also at floor level. Water is able to flow, or be wind driven, into the building via these openings. In several locations school staff has installed localized drainage to alleviate this condition. This condition can be viewed in the image below.

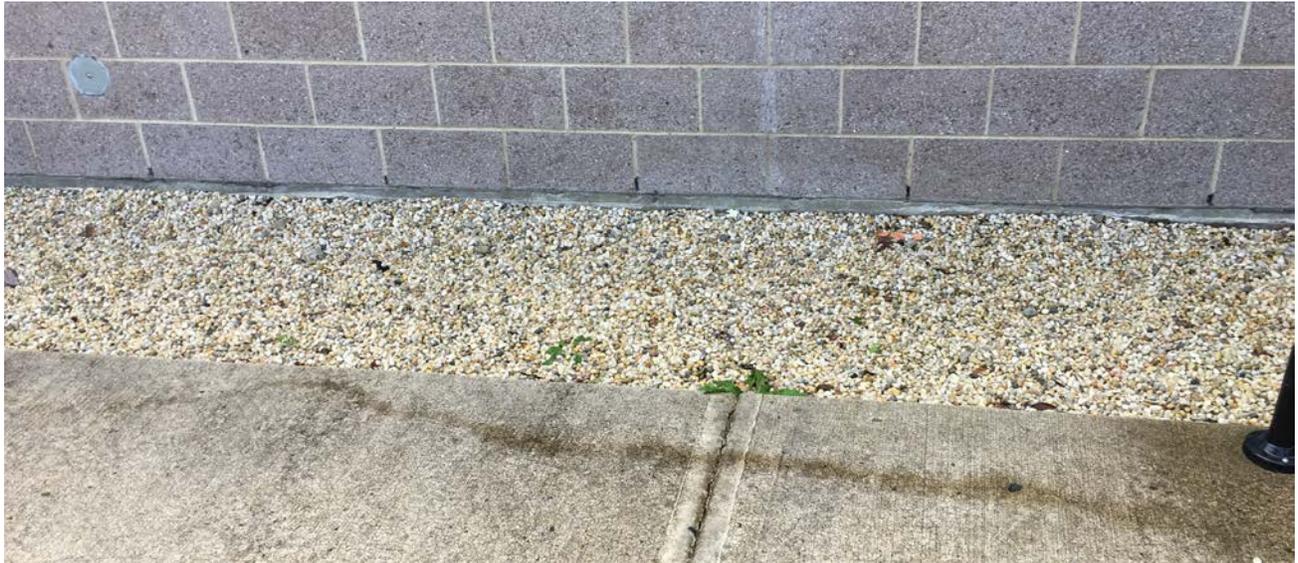
There are other areas where the sidewalk has been sawcut to create a permeable area between the hardscape and the building. This type of solution is an appropriate response to alleviate moisture issues as long as there is a way for water to be captured and moved away from the building.

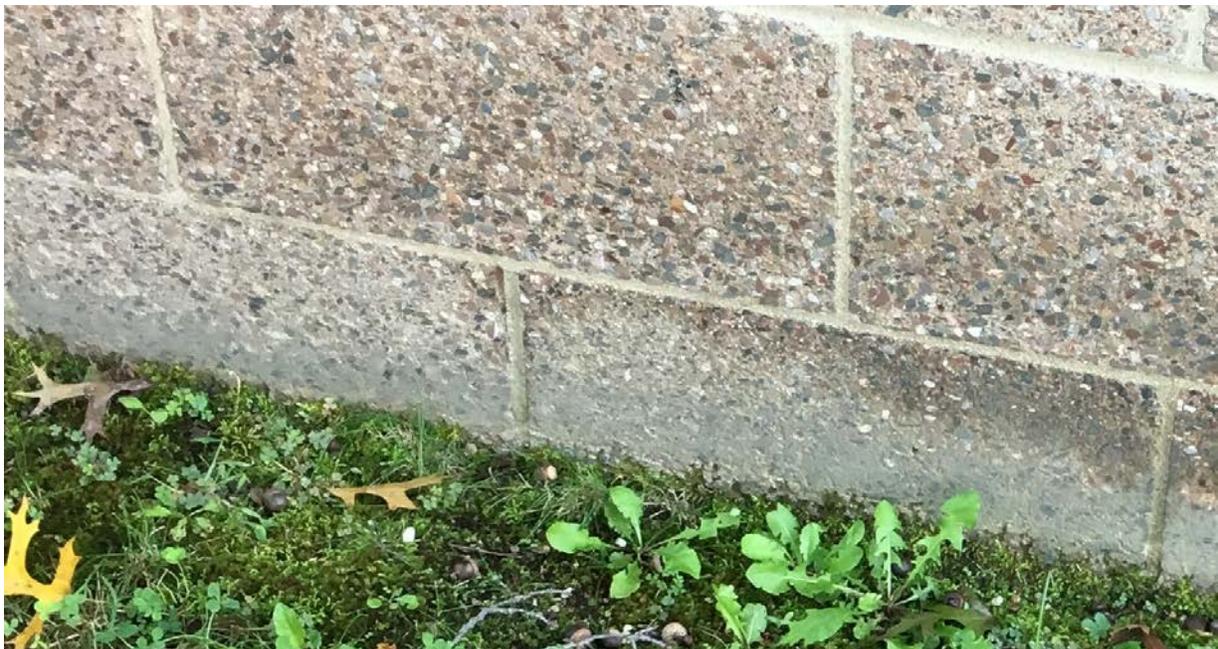
In addition to the areas where the water is allowed to flow toward the building, there are areas where the grade is against the building's concrete block face above the foundation sill without adequate flashings or weeps. This condition can trap water in the wall and lead to infiltration to the interior of the building.

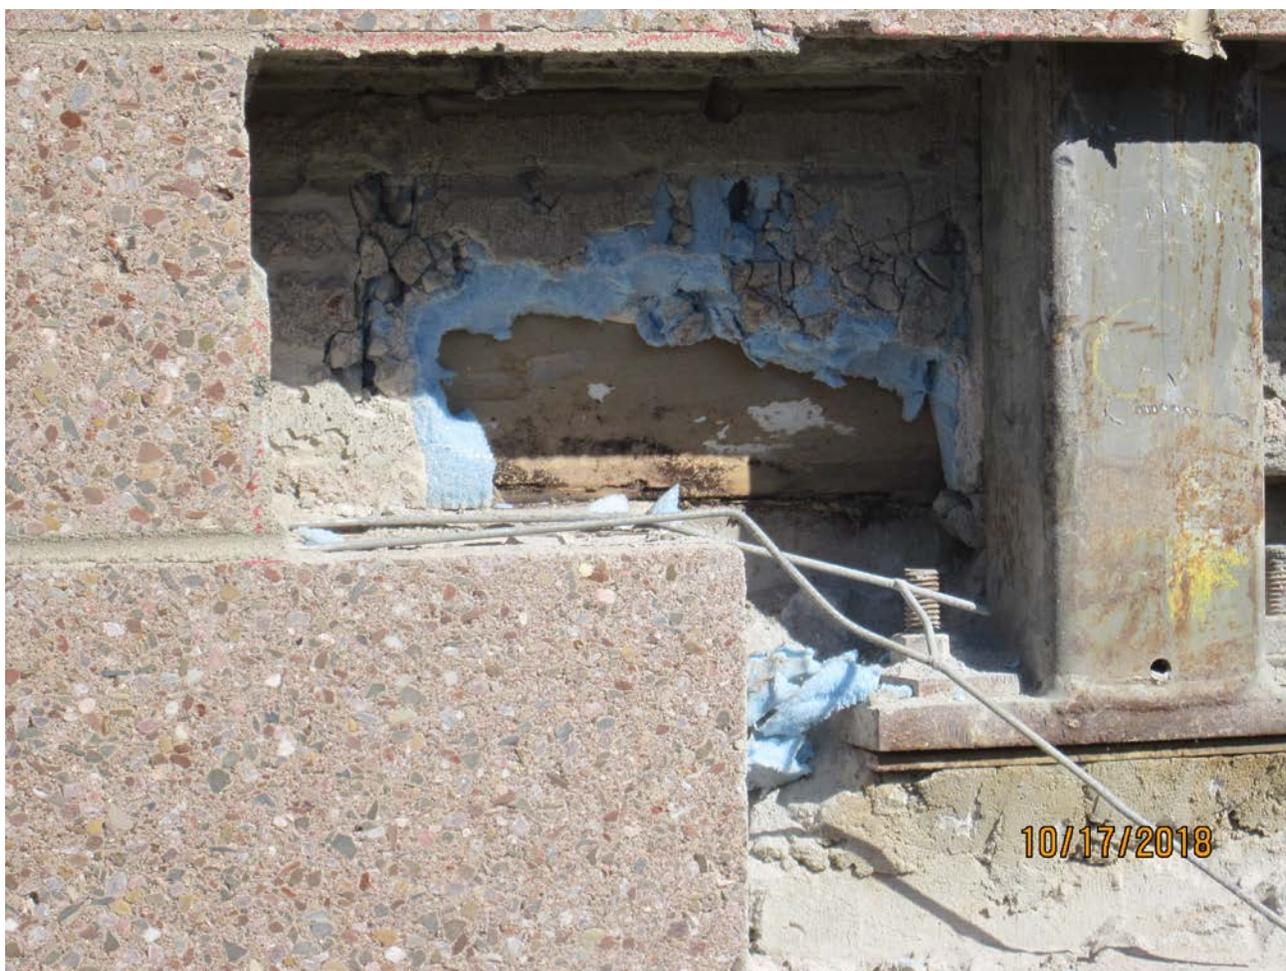
The oldest portion of the building is built with a construction of laminated layers of concrete masonry units (CMU), rigid polystyrene insulation board, and gypsum wall board (GWB) without space or cavity. This was a widely used wall type at the time the building was built in the early 1960s. It has no air, water or vapor barrier in the assembly. Water that penetrates the CMU is free to infiltrate the building or migrate back out of the wall. The GWB has organic material facing in the form of paper, which when it is wet, is suitable for mold growth in certain conditions. Where we opened this type of wall, mold was observed on the GWB.

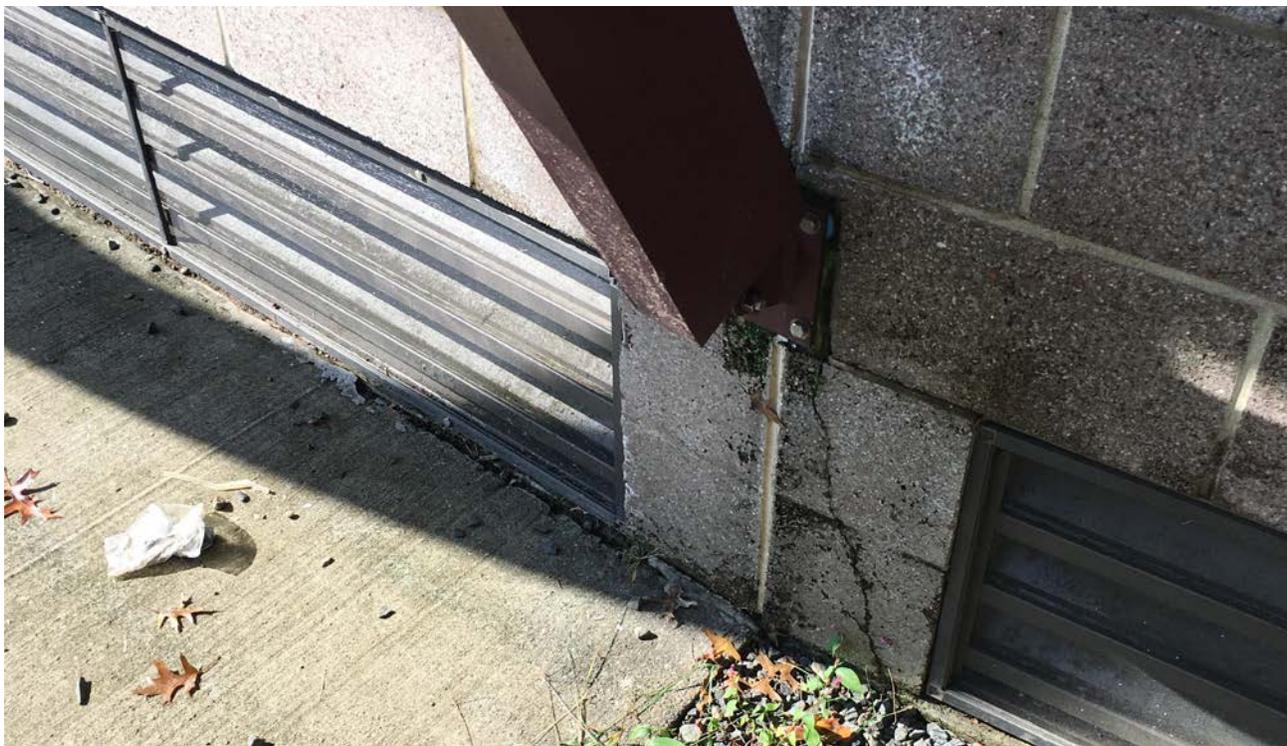
The destructive probes performed during the investigations revealed extensive failures of the cavity wall systems. Excessive penetration of water is allowed by failed joints and connections. The photo below shows cracked face block, badly sealed connection of a sunscreen strut, and a soft expansion joint – prone to failure.

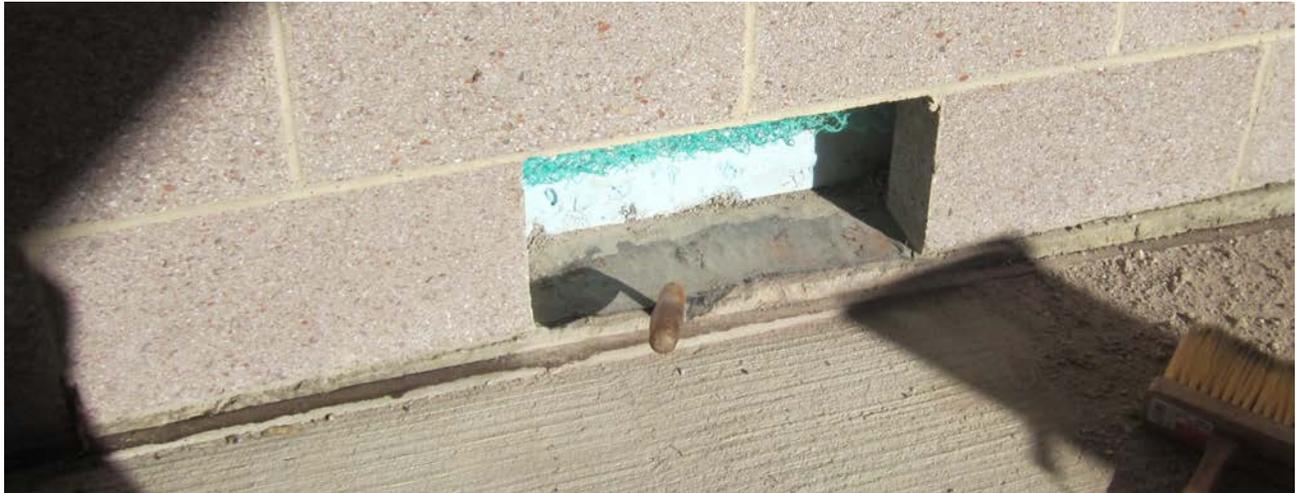
The placement and configuration of flashings is incorrect or incomplete and problematic in many locations. At all places where the wall was opened at the foundation sill or floor slab level, the base flashing was not adhered to the substrate and did not extend past the face of the wall. Thus, water is able to travel under the flashing and into the wall, and in some cases, fully through the wall.

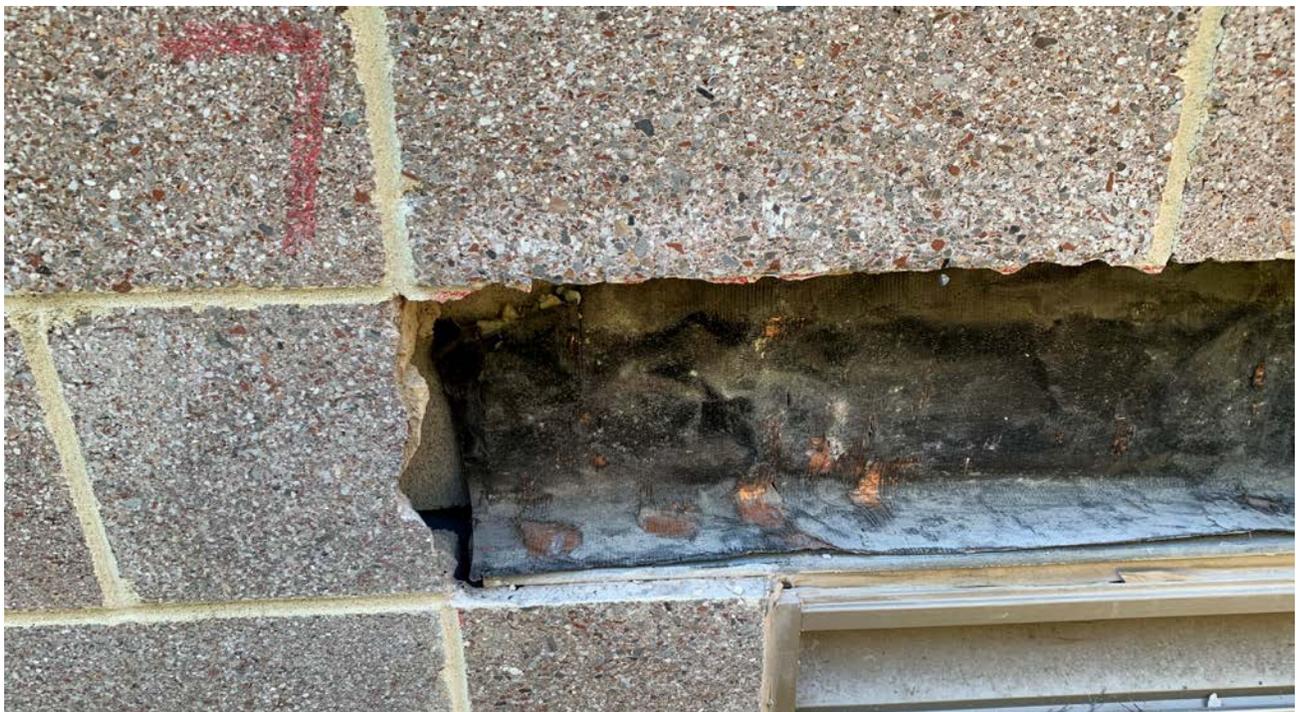
Flashings at horizontal openings have no end dams to help direct water to the appropriate weeps. And, as shown below, no drip edge flashing to convey water off of the surface below.

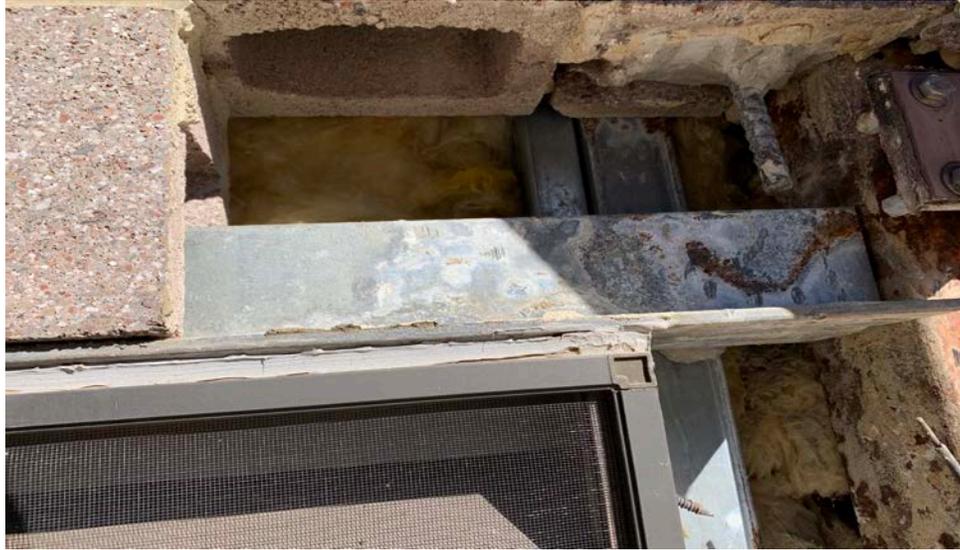
There are locations when the required flashing was not present. The photo below shows one such location. In this instance, the problem has persisted for so long that the exterior sheathing of the steel framed wall has deteriorated and fallen away. The exposed yellow fiberglass insulation and the steel studs should not be visible and materials are absorbing moisture and rusting respectively. Another issue seen on the right side of the photo is the lack of a continuous air and moisture barrier around the column to protect it from rusting.

Finally, the above photo shows the top right corner of a louver penetration for unit ventilator that is at grade level. The screen covering the louver was added by building staff to mitigate the entrance of mice and other vermin. As noted earlier in this report, there are water penetration issues at the base of these louvers due to finished grade conditions and directional flow of surface water.

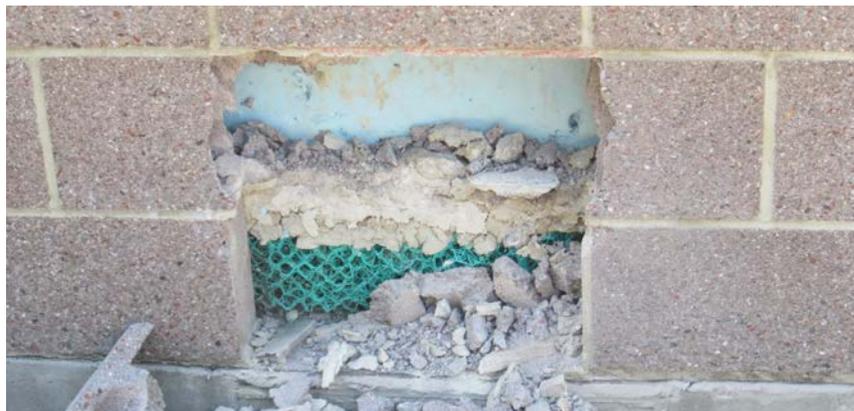
Another issue that is pervasive in the cavity wall construction is the blockage of the mortar net placed in the cavity to prevent fallen mortar from clogging the wall weeps. The green mesh in the photo below is the mortar net. The broken pieces of block and mortar are the result of making the hole in the wall. The continuous layer of mortar atop the mortar net has been in the wall since its construction. As seen below, the excessive droppings of mortar during laying up has created an effective dam, trapping water in the wall.

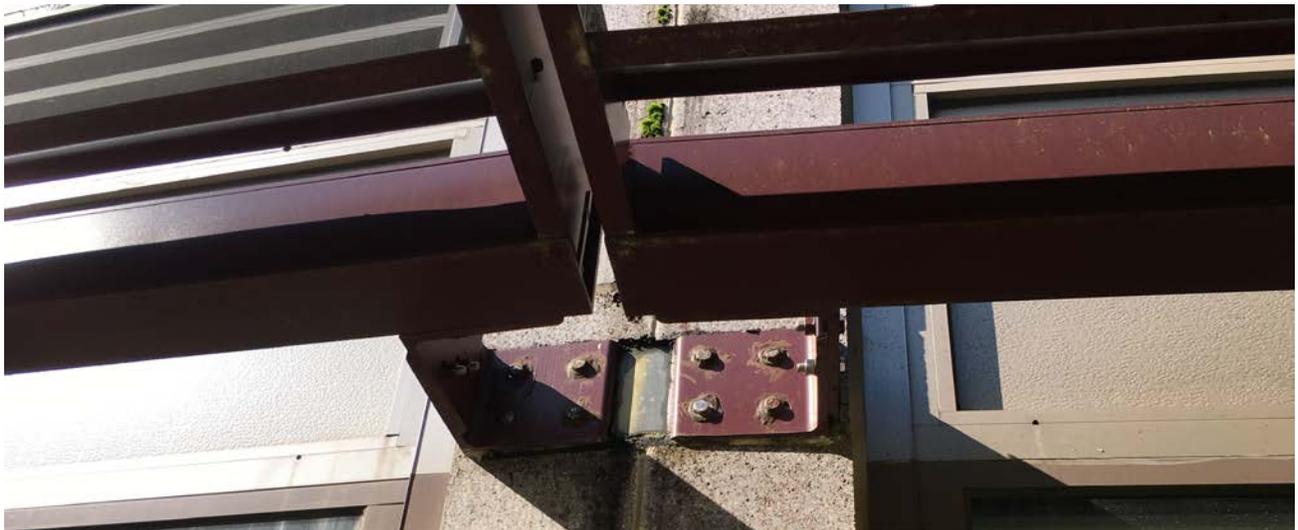
There are large, exterior mounted sunscreens on much of the South and West sides of Coleytown Middle School. The attachment of the brackets that support these sunscreens is inconsistent from location to location, and they are an observed source of water infiltration. In multiple locations the fastening plates straddle expansion joints in the wall construction. Beneath many of the sunscreen connections were very damp blocks with visible moss and blackened spots from long standing moisture conditions.

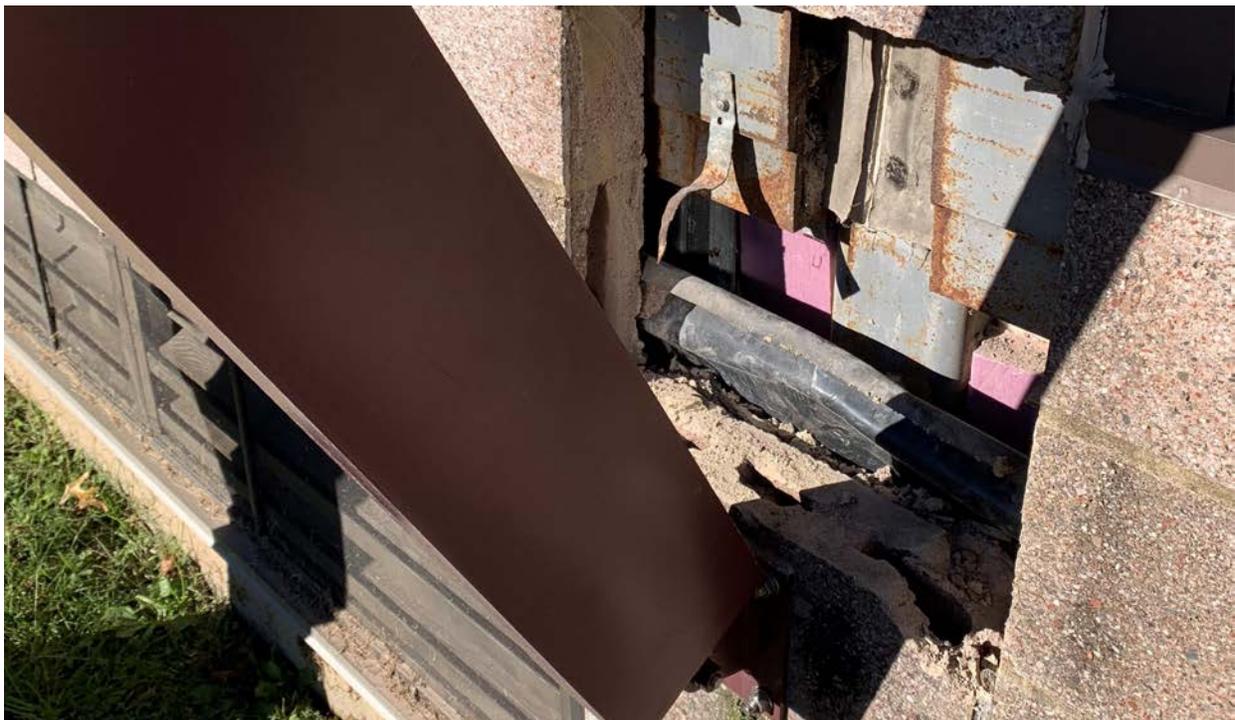
In many locations fastening plates are cut into the CMU construction with no flashings or adequate sealant.

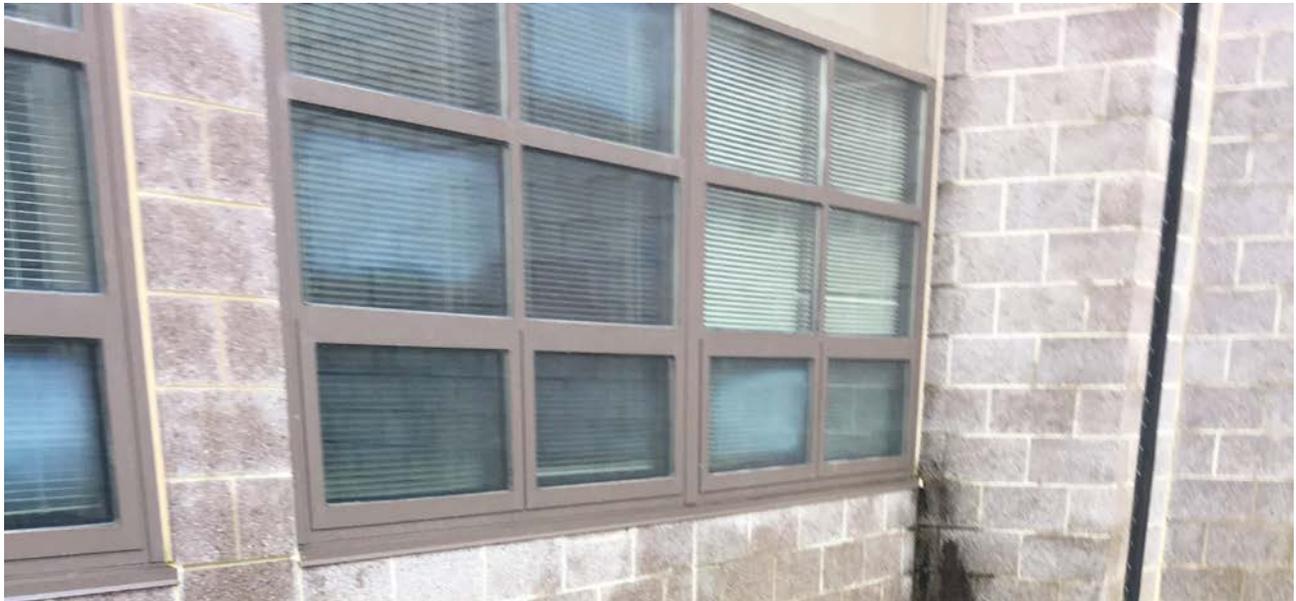
The total area of the facade is approximately 60,600sf; 22,000sf of facade is clad w/aluminum curtain window wall; 38,600sf is clad with ground face concrete blocks. Many of the insulated glass windows have failed and moisture is visible between numerous individual panes (as seen by clouded glass). The window system also has inadequate or missing sill and transition flashings allowing water infiltration. Some of the glazing gaskets have failed, which permits water penetration into the assembly, and ultimately, the building.

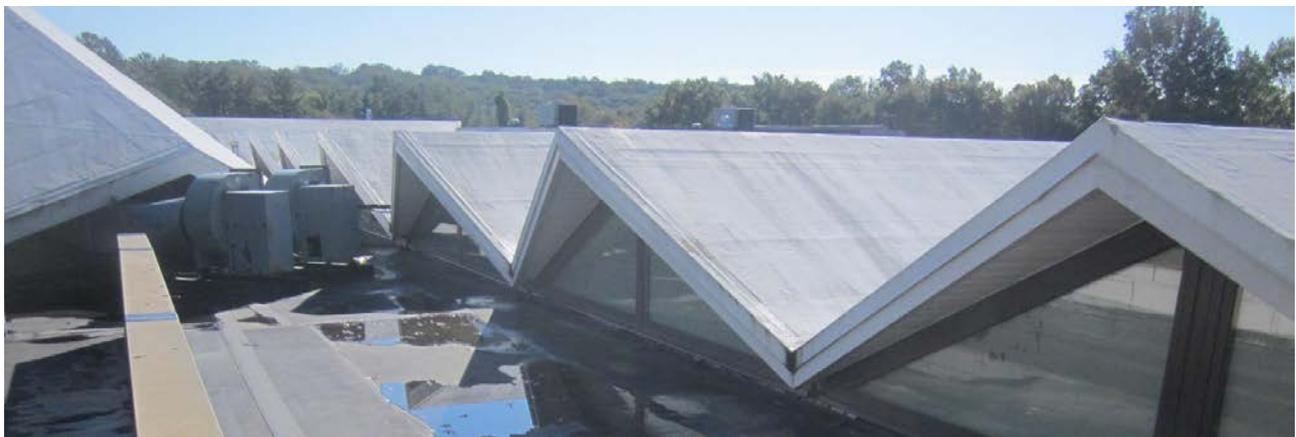
The clerestory windows within the roof triangles of the 1960's building is a potential source of leaking. As water or snow builds up on the roof, there should be at least a 12" roof return up the wall to reduce the opportunity of water to migrate into the building from the roof edge.

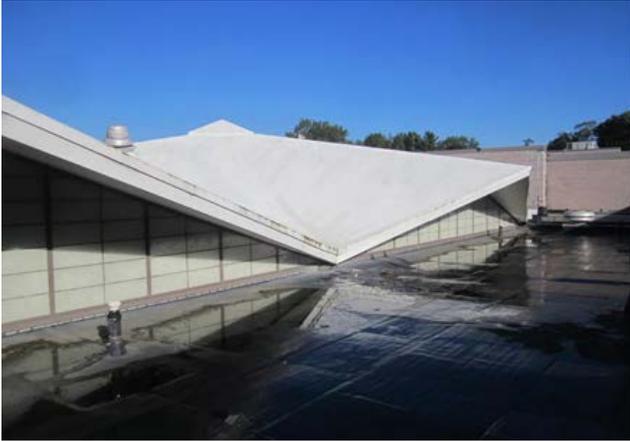
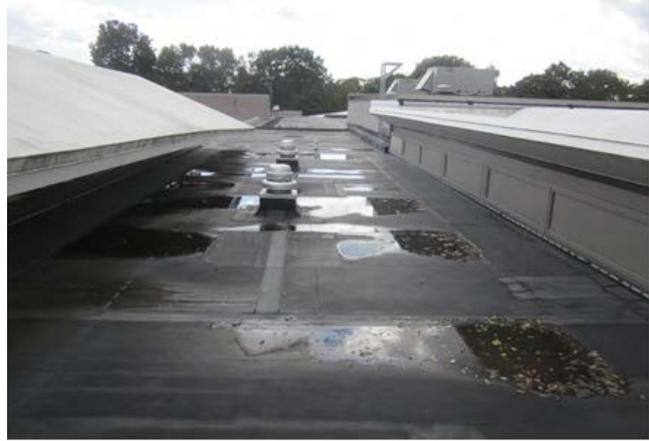
The roof is divided into twenty-five different areas for a total of approximately 105,840 square feet. There is about 65,670sf of flat roof area covered in black EPDM rubber or about 60% of the total roof area. The flat roof is over 18 years old. The balance of the roof (or the 40,170sf of pitched roof areas) is covered in white Hypalon roofing. It has aged out and the District has extended its life by applying coatings to keep it watertight. All roof areas are: 1) under-insulated' by current standards, 2) have wide-spread deficiencies, and 3) incorporate inadequate drainage provisions.

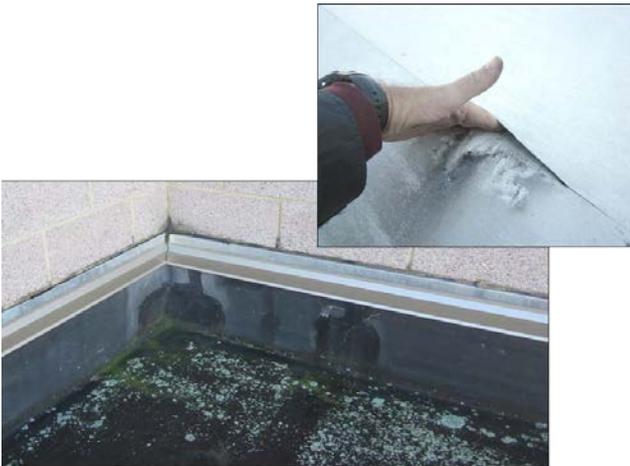
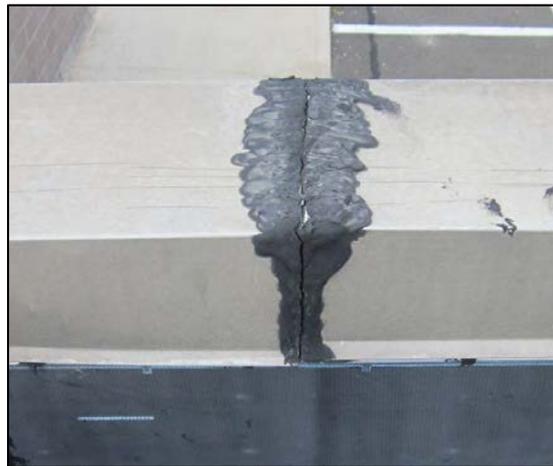
Among the observed deficiencies were: 1) organic growth on the roof, inadequate flashing, 3) failed seams, and 4) failed adhesion to adjacent surfaces. Here are some additional images:

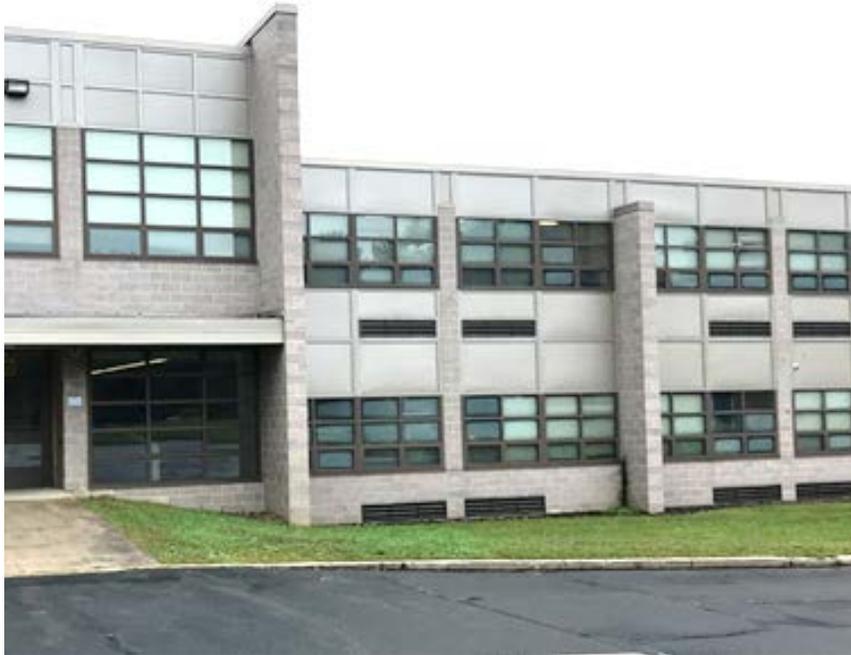
Figure 2: Location of Intake Louvers

- The first issue is the location of the intake louver. The unit ventilators in each classroom are connected to an exterior louver to provide outdoor air to the space. Typically, the louver would be installed a minimum of 12"-18" above grade to allow for snow build up on the adjacent grade and to avoid water infiltration from any adjacent ponding water. We found louvers for the majority of the grade level classroom unit ventilators to be at grade. Refer to Figure 2. This creates problems with excessive moisture and allows water infiltration into the UV. The cooling coil in the UV is not designed to dehumidify this excessive amount of moisture. Any excess moisture within the UV will settle on the drain pan and within the UV cavity.

1. The location of the bottom of the intake louver at finished grade - not industry standard minimum of 12" above grade allows excessive moisture/water into the UV equipment.

- Unit Ventilators –Shift the UV mechanical units ‘inboard’ by 8” to 12” to create an insulated space/plenum so that the exterior louver can be raised to 16” above finished grade.
- Condensate drain piping from each unit should be added.
- Retro-Commissioning of systems – complete air and water balancing; ensure all systems are operational.
- Supplemental cooling and dehumidification systems should be added to treat the large common spaces.

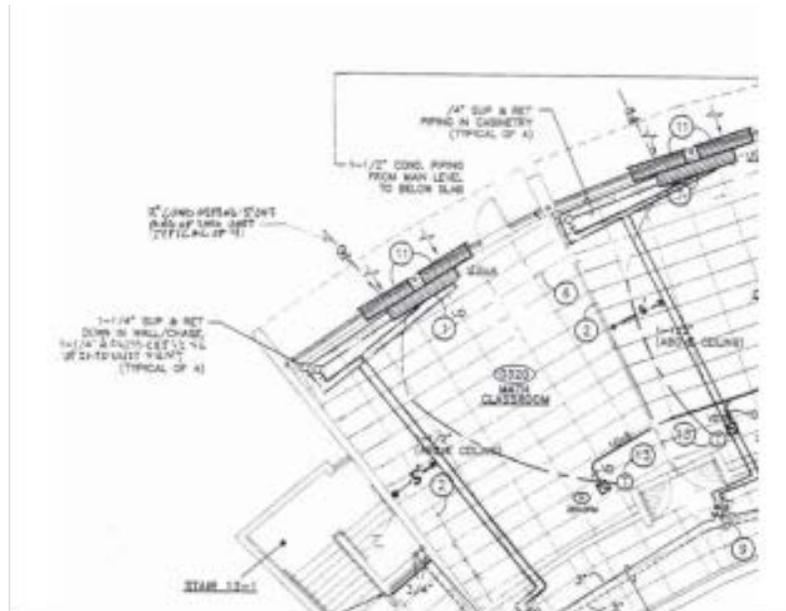
Figure 3: Condensate Removal Issues

- Building code requires that the condensate that forms in air conditioning units be drained away from the HVAC unit and connected to the sanitary system via an air gap. In several locations, it appears that the condensate drain is piped below grade to the adjacent soil. As indicated in Figure 3, the contractor extended the drain from the unit vent by 3' to 5', below grade. In some locations a dry well was noted, but in many locations the drain discharges directly below grade. This installation does not meet code requirements and will lead to the condensate not being able to be discharged. In addition, the open-ended pipe below grade is a conduit for ground water, insects, etc to enter into the building.

4. Condensate piping has been added, but it is drained to soil (not to sanitary piping).

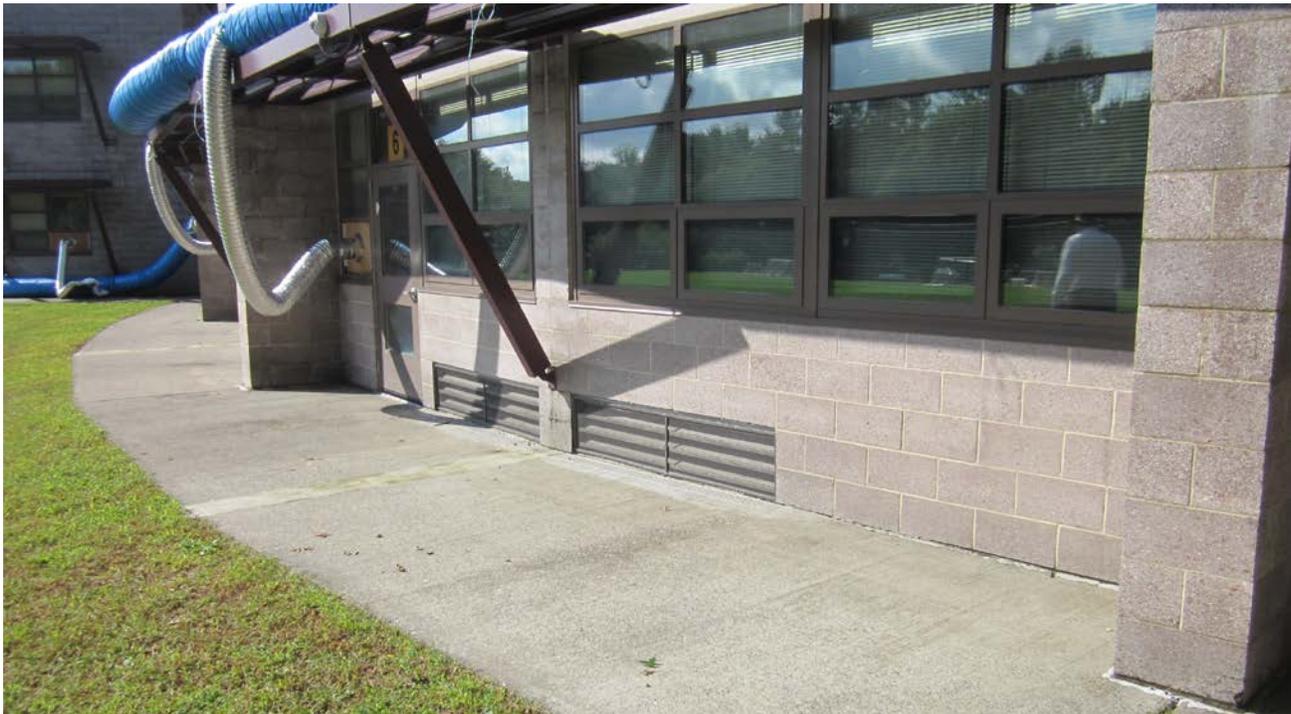
- Concrete walkways that are flat or pitch towards the building.
- Mechanical unit ventilator (UV) louver bases align with exterior grade.
- Grass areas against building without positive pitch or water outlets have created 'ponding' at the edge.
- Some exterior grades are built up against porous block exterior.
- Canopies and roof downspouts dump water at the building base.

In general, the majority of the perimeter finished grading requires modification.

- Where concrete sidewalk/hard surface meets building, surfaces should be lowered to minimum 6" below finished floor/foundation wall w/positive pitch.
- Where the grass lawn meets building base, the finished grade should be lowered w/an increased positive pitch and storm water collection.
- Where the existing adjacent grade is higher than the interior spaces, proper waterproofing and insulating of the wall is required.
- All stormwater drainage from roofs needs to be connected to a piping system and led away from building perimeter.

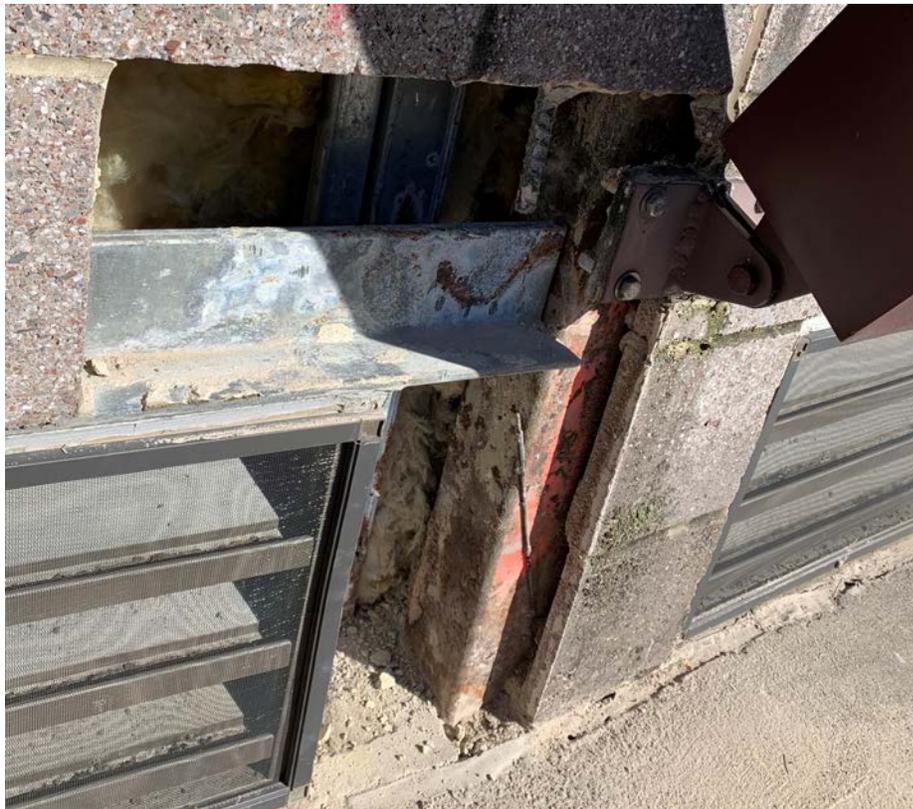
- Eight wall probes were wet; most showed signs of moisture infiltration, i.e. water stains, deteriorated gypsum board, and rusted metal studs.
- Rodent droppings were present in two wall probes.
- Mold on wall components was present at two wall probes.
- Corroded structural steel column was present at multiple wall probes.
- Multiple locations had strong dank odors emanated from the wall cavity representing long periods of moisture. Areas where this odor was observed included classrooms and corridor of the 2-story wing.

Issues with the facade are wide-spread and pervasive, localized repairs will not prevent future water entry and resultant issues.

- All of the ground face masonry walls should be removed and replaced. The report ultimately recommends removal of the entire exterior wall assembly and full replacement including interior finish.
- All of the windows and curtainwalls should be replaced as part of an exterior wall replacement project.
- The sun shades should be removed and an alternative assembly or method to control sunlight should be studied and installed.

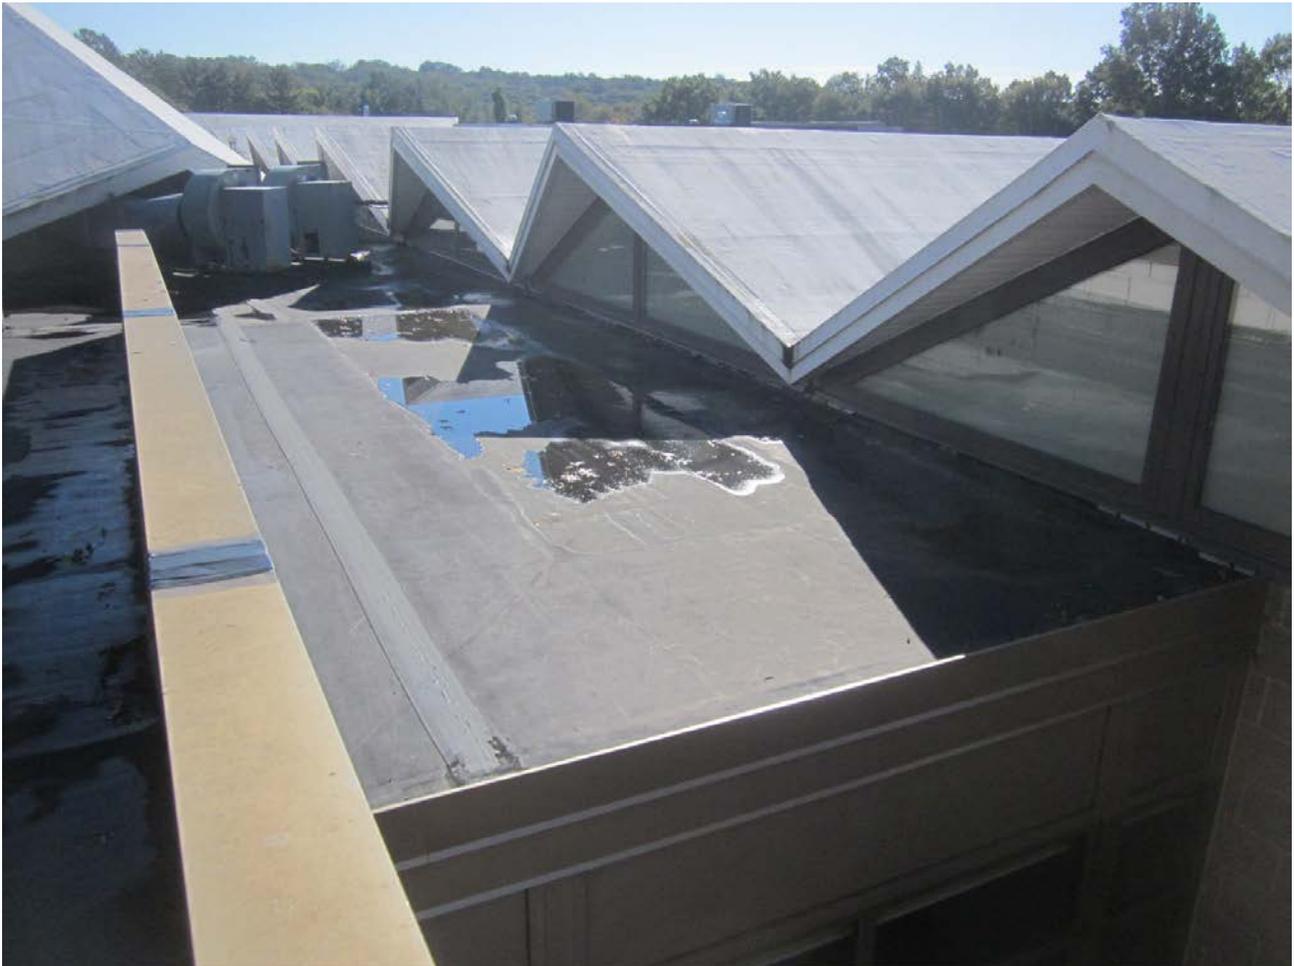
- The 18+ year old flat EPDM sections are approaching the end of their service life.
- The white, sloped Hypalon sections have failed and have been treated in the past to extend the usage.
- There is limited existing roof insulation. It most likely met building code requirements at the time of installation, but increased energy code requirements have changed the criteria for roof insulation since its original construction.
- Existing clerestory windows and other roof elements do not have at least a 12" curb to protect the interior finishes from water infiltration.

The entire roof should be replaced to be properly integrated with the wall and window systems and to provide proper slope for drainage and upgraded insulation to comply with the current building and energy codes. This approach will reduce heat gain/loss through the roof and improve occupant comfort. An analysis of different roofing systems should be prepared during the design phase of a replacement project.
