WESTPORT PUBLIC SCHOOLS COLEYTOWN MIDDLE SCHOOL

BUILDING ENVELOPE & HVAC SYSTEMS EVALUATION and RECOMMENDATIONS

December 12, 2018

KG+D Architects, P.C.
OLA Consulting Engineers
Watsky Associates

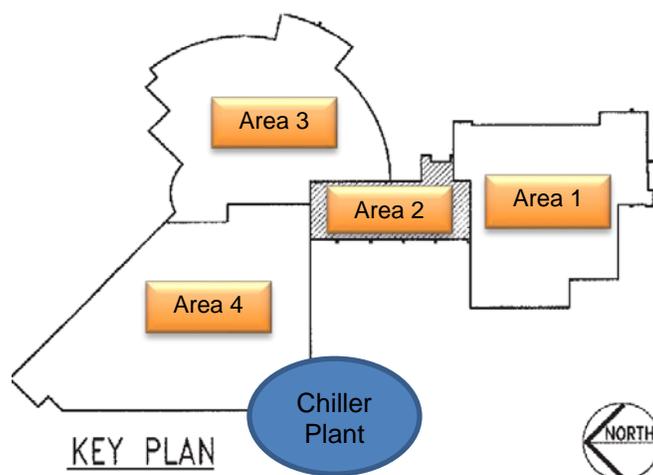
Figure 1: Four Areas of Coleytown Middle School

and air conditioning. For purposes of this analysis, we have divided the school into four separate areas noted in Figure 1 above.

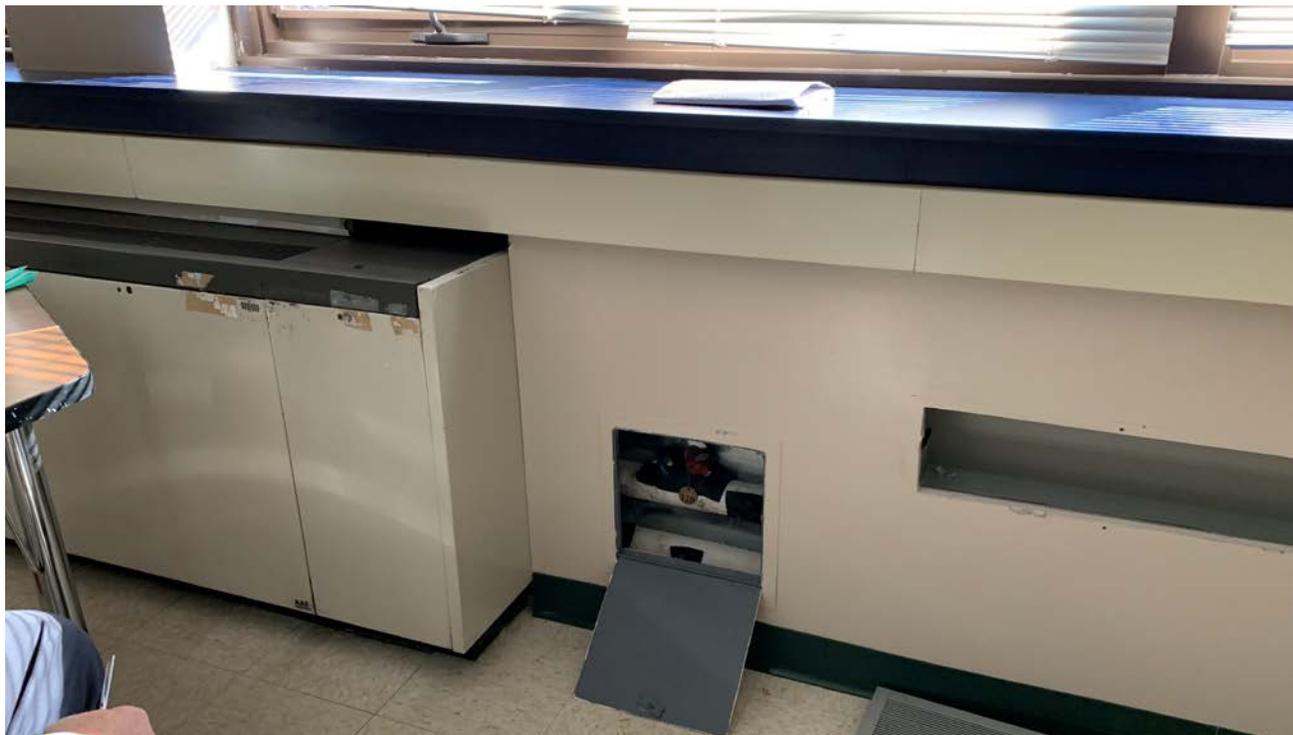
2. Portions of piping designed for heating are undersized for cooling requirements.
 3. UV control Sequence - The system was recently modified in an attempt to correct the humidity issue. The modification possibly turned off the unit's cooling/dehumidification ability during the summer months when it is needed to be 'on'.

4. Condensate piping has been added, but it is drained to soil (not to sanitary piping).

There are two options for addressing and upgrading the existing classroom mechanical systems. The first is to improve the in-classroom unit ventilator design and the second is to provide a ducted, more-centralized system. Here is an outline of the two systems in concept:
